Estates and Facilities Alert

Ref: EFA/2011/004 (UPDATE)

High-Voltage (HV) 11KV Switchgear –
Schneider Electric (Merlin Gerin) Ringmaster
RN2c, RE2c and RN6c ring main units

Product Safety Notice Reference Number: PSA-111201-318

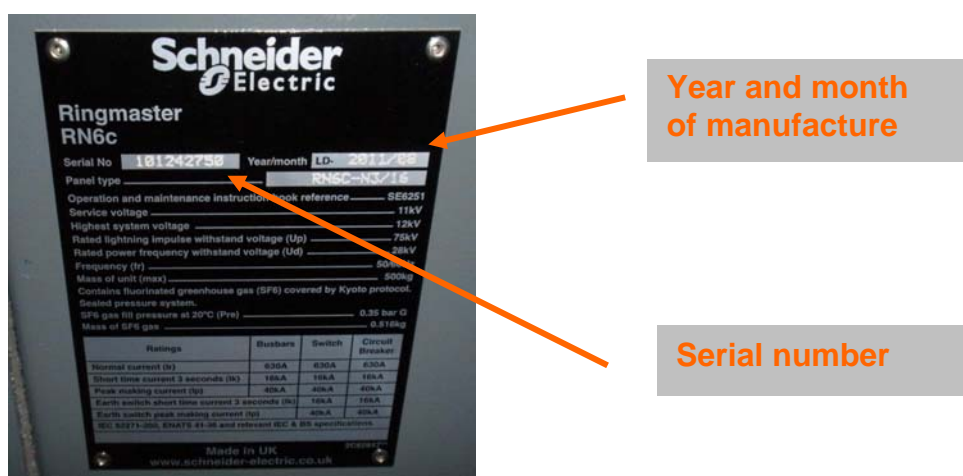
Data plate on the LV cabinet of the Ringmaster

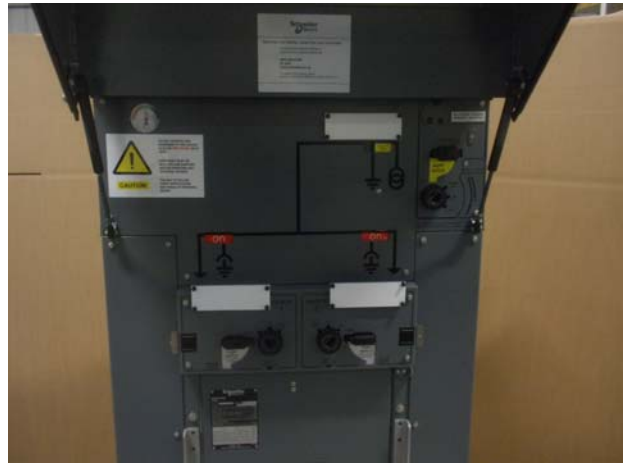
4.2 Ringswitch I and 2

Do not operate the either of Ringswitch mechanisms from their current service position

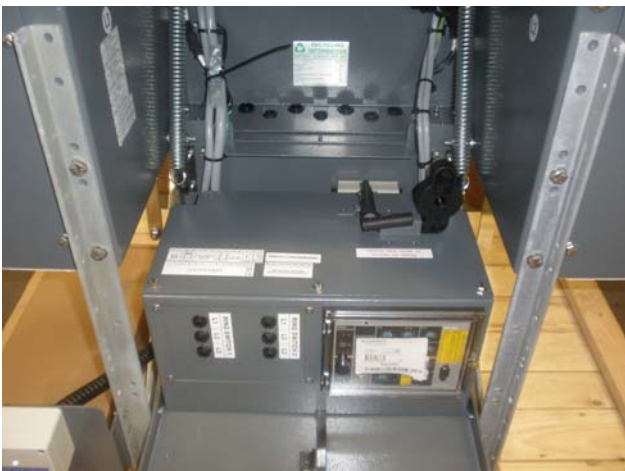
4.3 Open the LV cabinet and search for loose pieces of hardware in all accessible locations

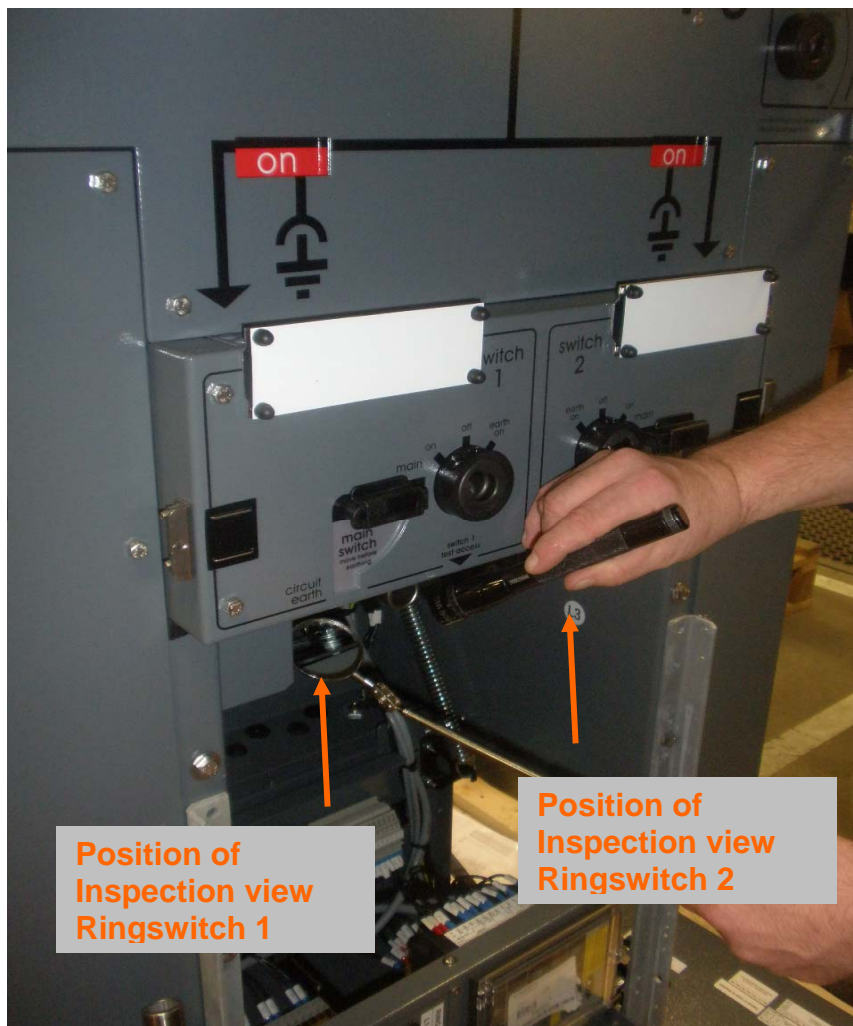
4.4 Check the parts to be inspected are still correctly located in Ring switch 1 drive shaft using a mirror and torch

4.5 Repeat the check for the correct location of hardware on Ring switch 2

If any of the parts to be inspected described below cannot be seen or is not in the positions shown in the photos STOP and DO NOT operate the Ringmaster.

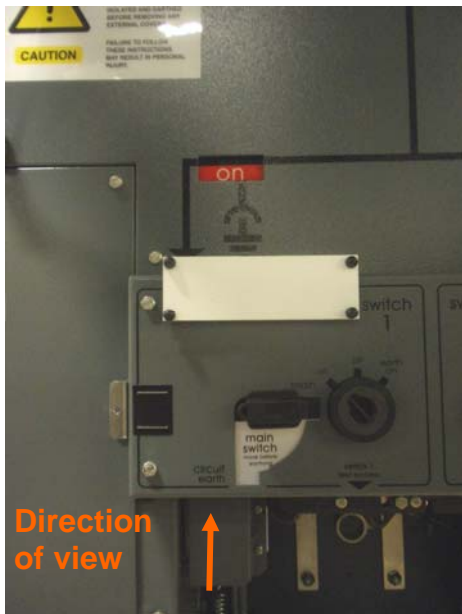
4.6 RSW1 Service position **Main selected**
Main ON

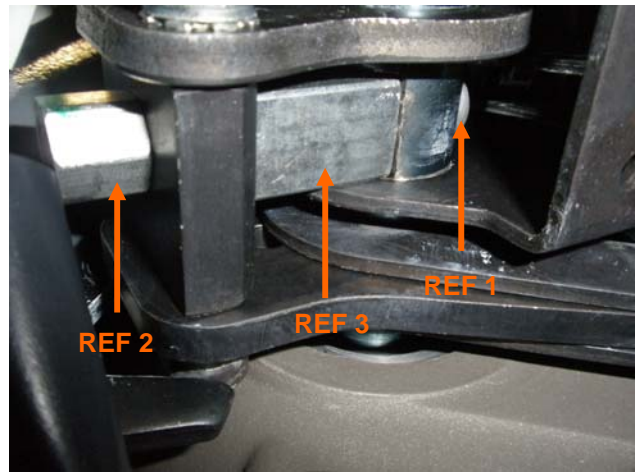
4.7 Correct view of hardware **Main selected**
Main ON

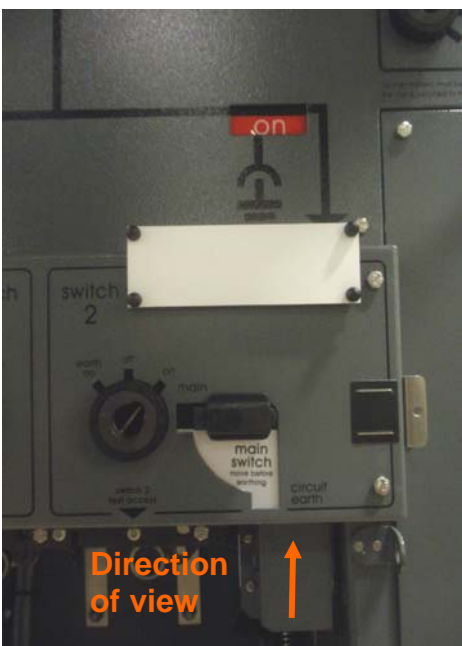
4.8 RSW2 Service position **Main selected**
Main ON

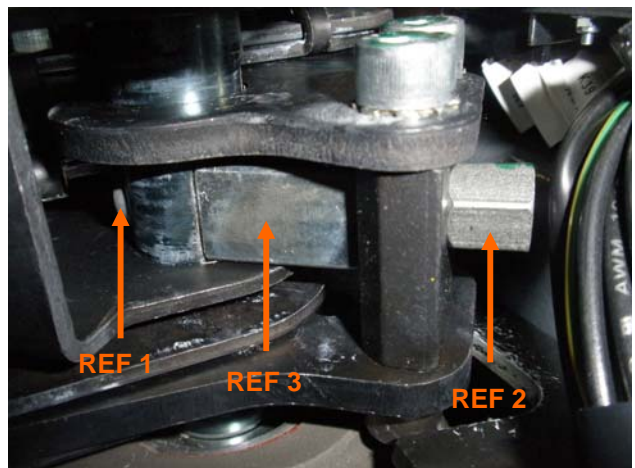
4.9 Correct view of hardware **Main selected**
Main ON

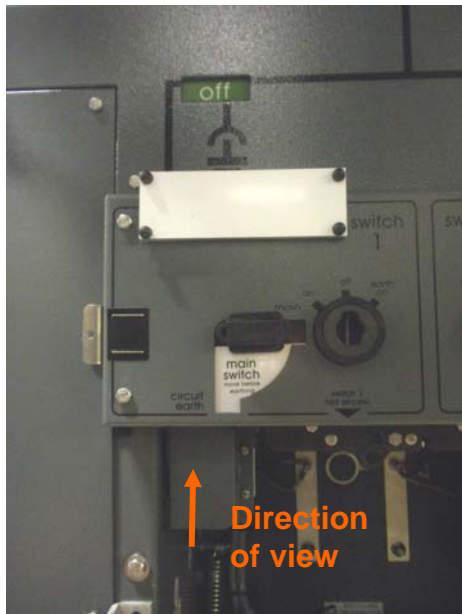
4.10 RSW1 Service position **Main selected OFF**

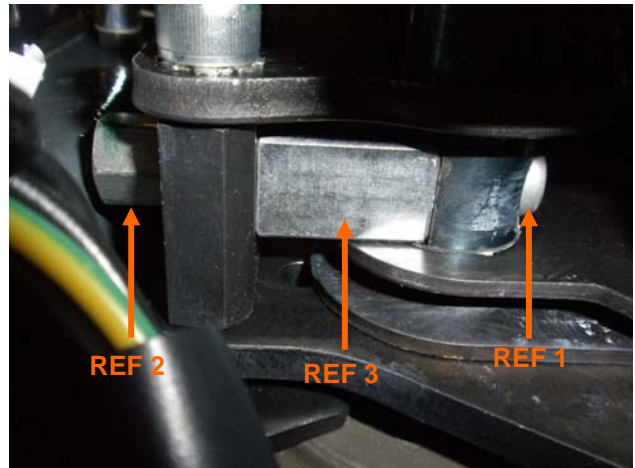
4.11 Correct view of hardware **Main selected OFF**

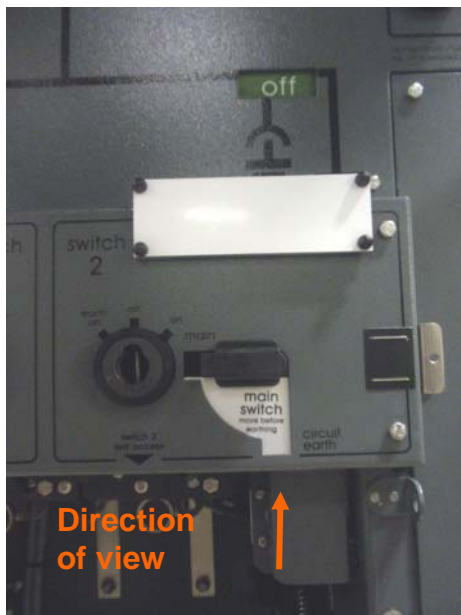
4.12 RSW2 Service position **Main selected OFF**

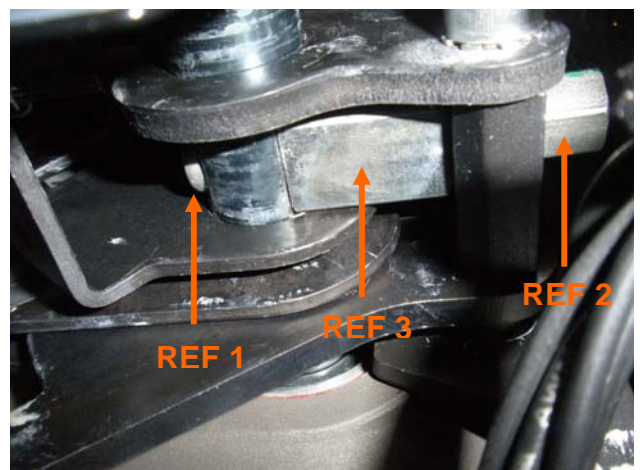
4.13 Correct view of hardware **Main selected OFF**

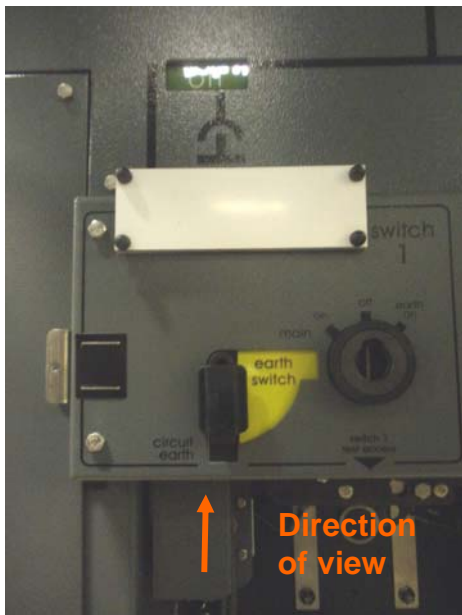
4.14 RSW1 Service position **Earth selected OFF**

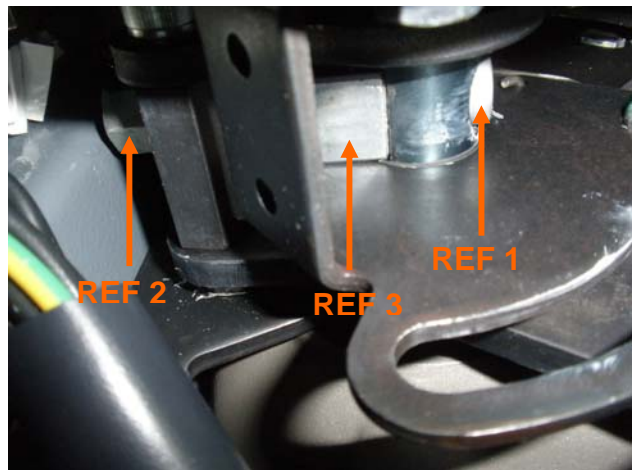
4.15 Correct view of hardware
Earth selected OFF

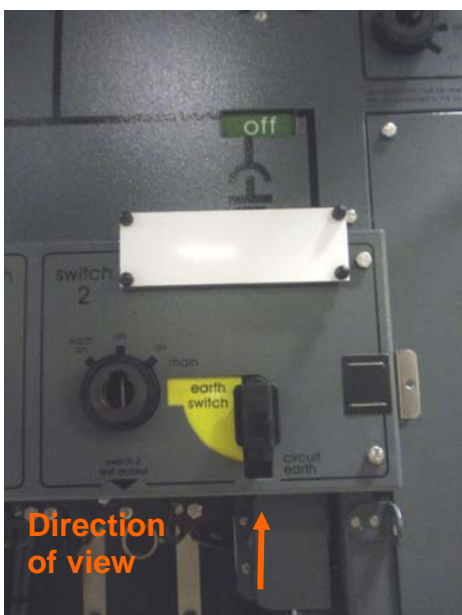
4.16 RSW2 Service position **Earth selected OFF**

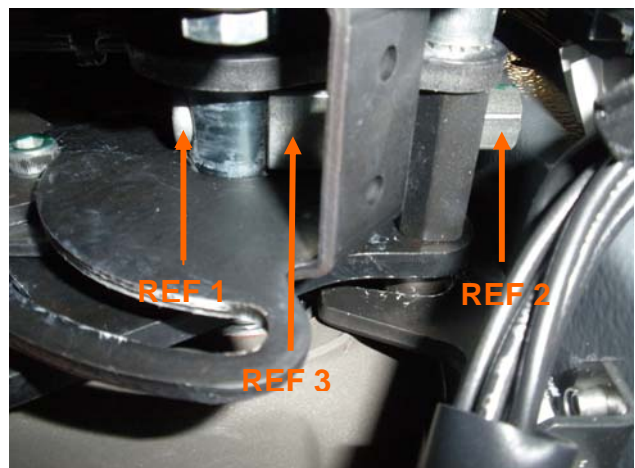
4.17 Correct view of hardware
Earth selected OFF

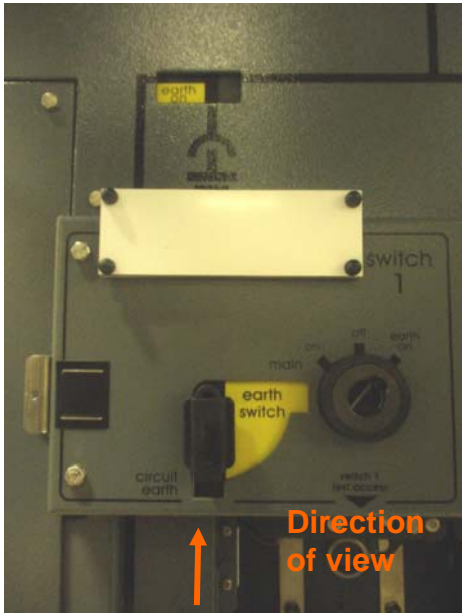
4.18 RSW1 Service position **Earth selected**
Earth ON

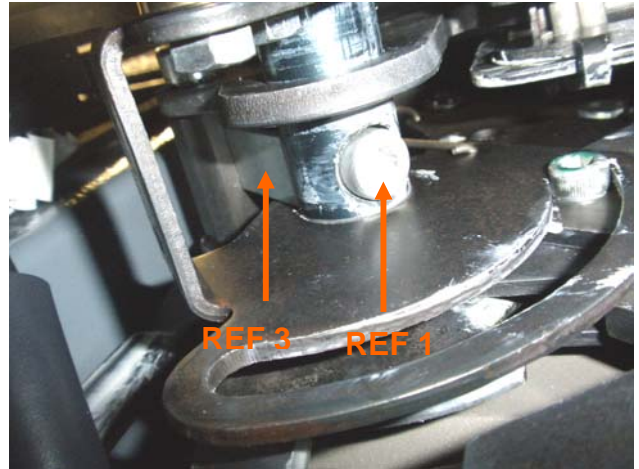
4.19 Correct view of hardware
Earth selected Earth ON

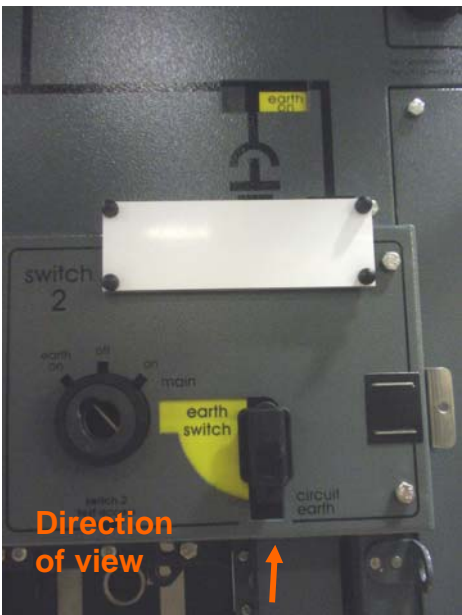
4.20 RSW1 Service position **Earth selected**
Earth ON

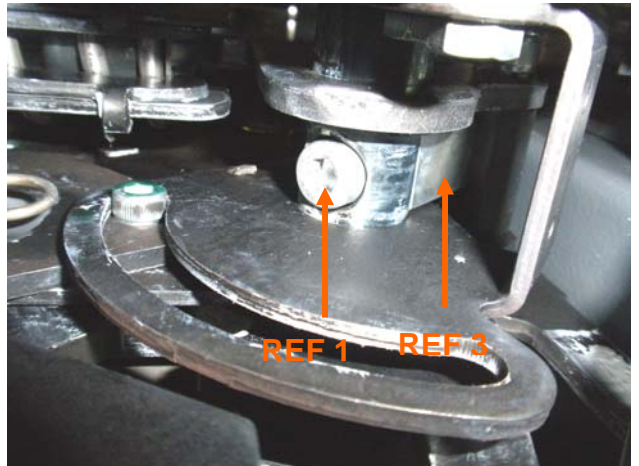
4.21 Correct view of hardware
Earth selected Earth ON
