Estates and Facilities Alert

Ref: EFA/2012/001 Issued: 19th January 2012

Integral side-stay mechanism window restrictors fitted with plastic spacers and used in many window applications

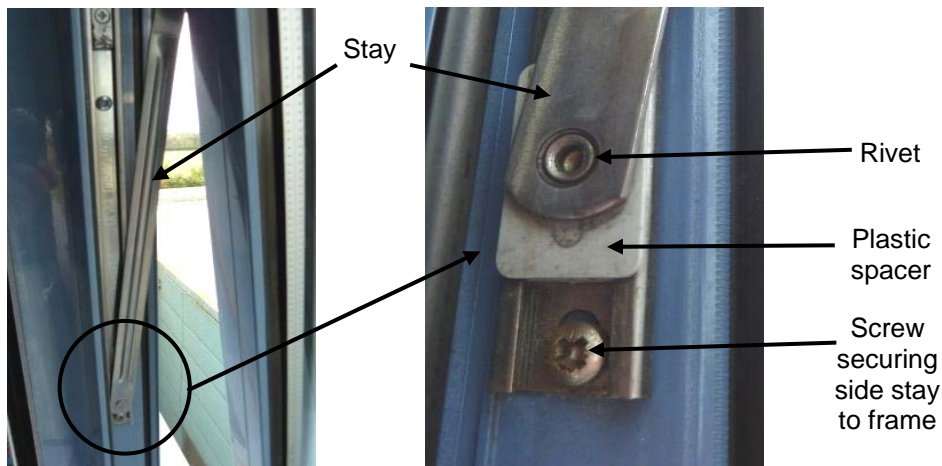
1. An incident has been reported in which a person fell from a 5th floor window after overcoming a window with a side-stay restrictor which, in conjunction with a second restrictor (on the opposite side), normally restricts the opening to 100mm.
2. Examination of the restrictor identified that a plastic spacer had deteriorated and cracked, allowing excessive movement between the stay and retaining rivet. The stay had eventually separated from the frame allowing the window to be opened beyond 100mm.
3. Where two restrictors are fitted, failure of one may be sufficient to allow the window opening to be forced beyond 100mm. The photographs below show the style of integral side-stay mechanism securing the side of the window to the frame.

Photographs showing side-stay mechanism and plastic spacer.

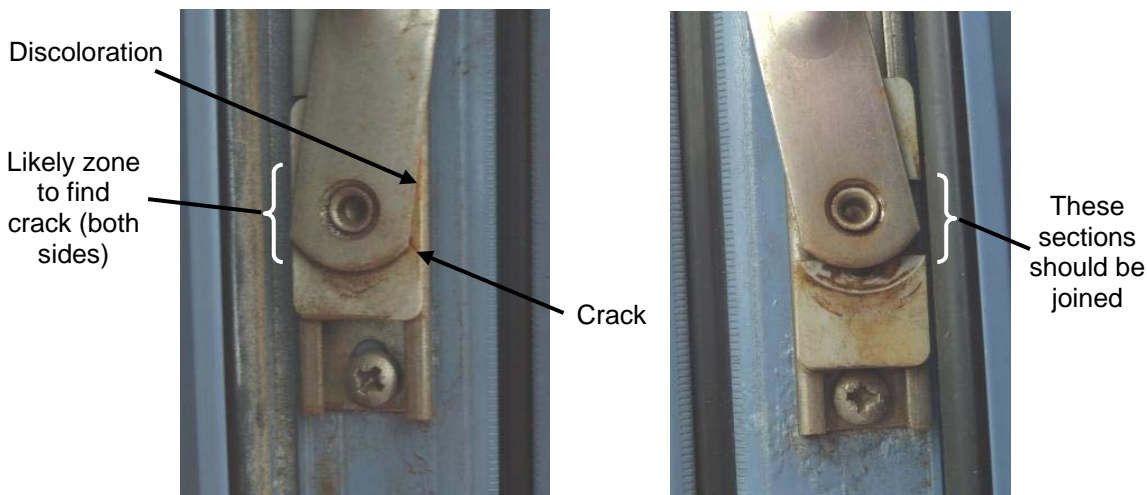
4. The rivet in this case had suffered corrosion, leading to cracking of the plastic spacer. The photographs below show corrosion stains on cracked plastic spacers (an orange colour). By this time urgent action is required.

Photographs showing cracked and completely broken spacers (with staining).

5. A contributory factor to the deterioration of the spacer may have been excessive use of steam or chemicals used for cleaning, and/or sunlight. The window had been installed for over 10 years.
7. This alert supplements previously published advice (see Additional Information for Northern Ireland – page 3).

8. Windows with this type of integral side-stay restrictor should be examined for deterioration and damage and, where necessary, remedial repairs and control measures implemented.
9. Where a plastic spacer shows signs of deterioration, e.g. discoloration or cracking, the following interim actions should be considered:
 - Permanently secure the window closed;
 - Fit a secondary window restrictor, requiring a special tool to remove it, so that if an original side-stay mechanism fails, the secondary device will prevent the window from opening beyond 100mm.
10. A preventative maintenance programme should be put in place to carry out periodic inspections for damage of side-stay mechanism type window restrictors.
