# Medical Device/Equipment ALERT

Ref. MDEA(NI)2006/45

Issued: 26 July 2006

Ref: Potential for change of rate display format in IVAC P4000 Syringe Pumps

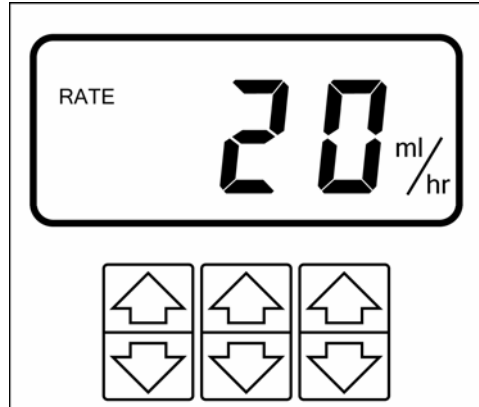
In the reported anomaly the pump can enter a rare software state in which low rates are displayed in the format normally used for high rates. For example, where 20 millilitres per hour would normally be displayed as '20.0ml/hr' it is instead displayed as '20ml/hr'.

### Display operation during anomaly for rates of $\leq 99.9$ ml/h

The effect of this anomaly is to move the displayed rate one digit to the right, thus changing the keys required to set rates of less than 100ml/h. For example, when setting a rate of 5ml/h the user would normally press the middle, 'up' arrow key five times. However, performing the same key presses during the software anomaly would result in a rate of 50ml/h being set. While the data on the display remains correct, Cardinal Health consider that there is small risk that the anomaly may lead to an incorrect rate being set by the user.

The IVAC P4000 syringe pump is an old design that was last manufactured seven years ago and is no longer considered 'State of the Art'. The legacy nature of this product and the technology on which it is based make it impractical for Cardinal Health to provide a software upgrade to correct the anomaly. Furthermore, the majority of IVAC P4000 pumps manufactured are in excess of ten years old and are therefore beyond their designed operational life. Consequently, Cardinal Health recommends that all IVAC P4000 pumps be removed from use and

decommissioned. For pumps that were manufactured after July 1996 Cardinal Health may offer a preferential rate on the purchase of a replacement device. Please contact your local Cardinal Health representative for details.
