Medical Device/Equipment ALERT

Ref. MDEA(NI)2007/03

Section
Medical Device/Equipment: Ferno Falcon Six and Hawk Six ambulance stretcher trolleys.	▶ ①
Problem: MHRA and Ferno (UK) Ltd are aware of several incidents involving weld failure of the foot end lock bracket of Falcon Six and Hawk Six ambulance stretcher trolleys. A customer advisory notice warning users about this problem has been issued, but not all of the affected devices have been traced.	▶ ②
Action by: All those involved in the use or maintenance of ambulance stretcher trolleys.	▶ ③
Action: <ul style="list-style-type: none"> Identify all Ferno Falcon Six and Hawk Six stretcher trolleys. If your organisation has not yet been contacted by Ferno UK Ltd to arrange for the strengthening bracket to be fitted contact Ferno Fieldcare (Tel: 01274 854 511). Check the integrity of the welds as detailed in the manufacturer's service book. If any stretcher trolley shows signs of weld failure remove it from use and contact Ferno Fieldcare immediately for advice. 	▶ ④

Falcon SIX Stretcher Trolleys Modification

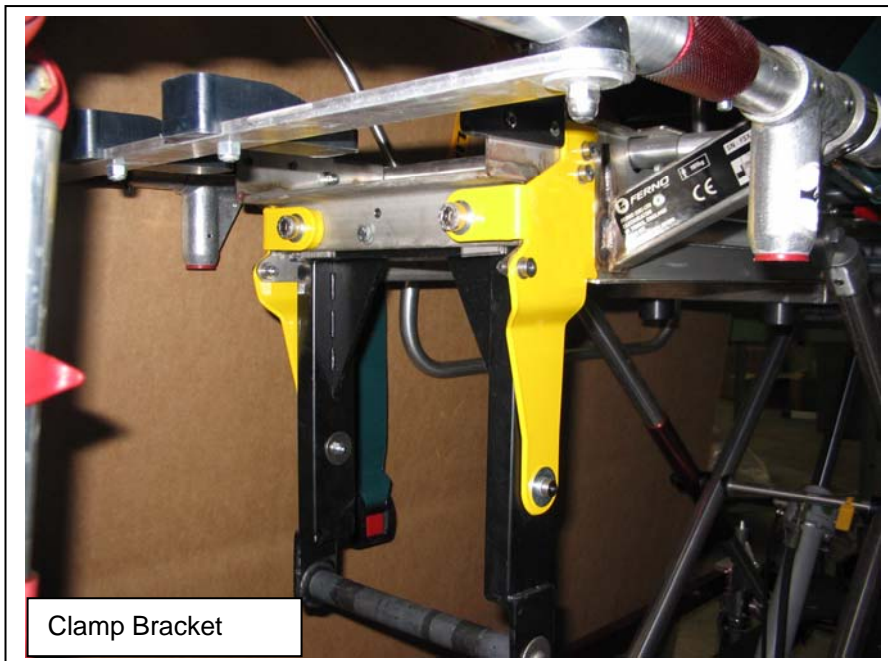
Stretcher Trolley Lock Bracket – Addition of Clamp Support Bracket

Following our advisory notice of October 2005, further extensive testing has shown that the area around the welded foot end lock bracket support on the Falcon SIX trolley will benefit from additional bracing. To meet this identified need a simple bolt on bracket has been designed and is now available for fitting.

You will be contacted within the next few weeks in order to arrange for this work to be carried out. Should you wish to nominate a specific contact then please advise our Fieldcare Division, contact details below.
