Medical Device/Equipment ALERT

Ref. MDEA(NI)2007/093

Section
Medical Device/Equipment: General ultrasound scanner: Nemio and Nemio XG systems manufactured by Toshiba Medical Systems Ltd.	▶ ①
Problem: <ul style="list-style-type: none"> A software error has been identified which can lead to an increased transducer tip temperature and an increased thermal index, along with incorrectly displayed MI (mechanical index) and TI (thermal index) values. Some of the acoustic power values in the manual are incorrect. 	▶ ②
Action by: Radiologists and radiographers.	▶ ③
Action: <ul style="list-style-type: none"> Identify implicated devices (see device section overleaf). Ensure you have been contacted by the manufacturer to arrange for a software upgrade and replacement user manuals. Follow guidance given by Toshiba to ensure the safe use of the device in the interim before the software upgrade is performed (see appendix). 	▶ ④
Distributed by NIAIC to: Chief Executive of each HSS Board Chief Executive of each HSS Trust Chief Executive of each Agency NIAIC Liaison Officers For onward distribution see Section 5	▶ ⑤

Customer Notification EU-2512

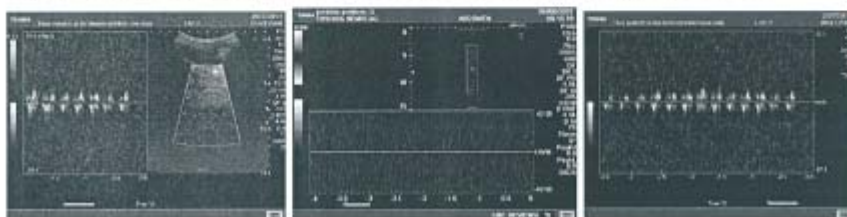
(1) When a transition is made from the Dynamic Flow mode to the Full-screen pulsed Doppler (PWD) mode, the maximum temperature of the transducer surface may reach 51°C if the transducer is applied to the same position for 30 minutes (exceeding the limit of 43°C as described in IEC 60601-2-37).

- Avoid scanning in Dynamic flow mode together with full screen PWC mode

Allowed

Avoid
