Medical Device Alert

Ref: MDA(NI)2009-004 Issued: 22 January 2009 at 17:00

Enteral feeding pump. Flocare Infinity pump model 35679 and Flocare Infinity Plus pump model 35680 manufactured by Nutricia. Specific serial numbers and software versions.

**Flocare® Infinity Enteral Feeding Pump (EFP)
FSCA dated 17-11-2008
Pump check and application of software version 3.13**

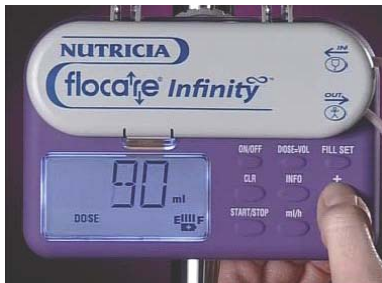
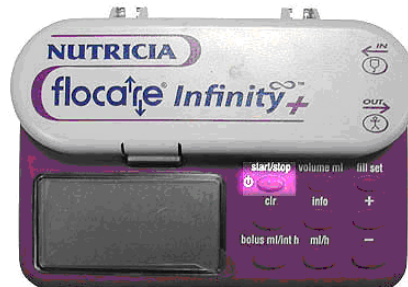
Due to a software irregularity, pumps have the potential to deliver feed at a higher rate than that programmed. This may go undetected as the display shows the programmed rate not the actual rate.

The manufacturer has issued an accelerated service programme to apply new software to the affected pumps.

- Identify affected pumps (see device section overleaf).
- Ensure that users are aware of the manufacturer's Field Safety Notice (see appendix). Nutricia will contact customers to arrange a service schedule.
