**AN (NI) 2002/05**

**DATE: 15 May 2002**

**NORTHERN  
IRELAND  
ADVERSE  
INCIDENT  
CENTRE**

**TALENT STENT GRAFT SYSTEM: CONNECTOR  
BAR AND STENT SPRING FRACTURE AFTER  
IMPLANTATION**

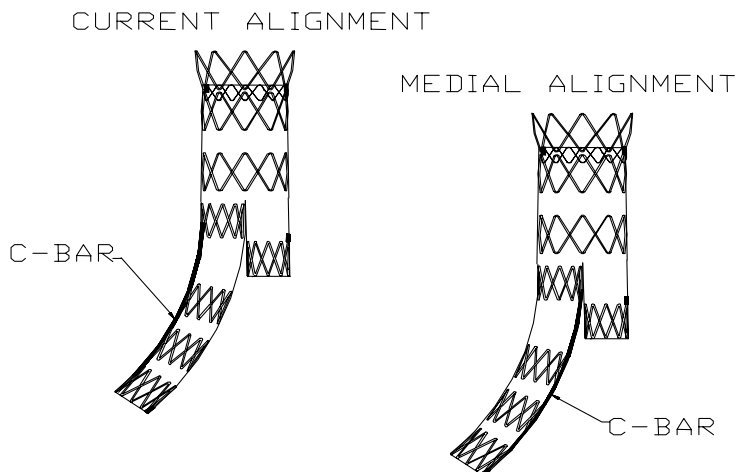
**Diagram of TALENT stent graft: Connector Bar (C-Bar) Orientation  
(copied from Medtronic Product Update of April 2002)**

The TALENT stent graft incorporates a longitudinal nitinol wire (known as the connector bar) joining the circumferential stent rings or springs, along the length of both the ipsilateral (integral) and contralateral (separate) device limbs. Within the ipsilateral limb, the connector bar lies along the inside of the curve (lateral position) formed by the natural iliac bifurcation (see diagram). For the contralateral limb, however, the clinician is able to choose to orientate the connector bar along the outside (medial position) of this curve where the angle is usually less acute.

The vast majority of connector bar fractures have occurred in the ipsilateral limb. Explant analysis has confirmed these to be fatigue fractures which began some time after device implantation. It is believed that the tighter angle to which the lateral connector bar in the ipsilateral leg is subjected, compared with medial placement for the contralateral leg, may be giving rise to these fatigue fractures.

6. Ensure, for all future implantations of TALENT stent grafts, that the connector bar of the contralateral limb is orientated in the medial position, ie the outside of the bend at the natural iliac bifurcation.
7. Report all adverse incidents involving TALENT grafts, including confirmed or suspected cases of connector bar or spring fracture, to Medtronic AVE and to NIAIC. Ensure that any explanted stent grafts are retained for analysis by Medtronic AVE, according to their explant analysis procedure.
8. Send copies of any X-rays showing confirmed/suspected connector bar or spring fracture, together with details of any associated clinical sequelae, to Medtronic AVE and to NIAIC. This will enable a clearer understanding of the longer-term clinical significance of stent fracture to be gained.

Medtronic has therefore redesigned the TALENT stent graft to reduce the risk of fracture, by moving the connector bar of the ipsilateral limb to the medial position (see diagram). Modified devices will shortly be made available. In addition, the surface uniformity of the nitinol wire has been improved to remove irregularities, which may have given rise to fatigue crack propagation.
