**SN (NI) 2002/31**

**NORTHERN  
IRELAND  
ADVERSE  
INCIDENT  
CENTRE**

**STOLLENWERK AMBULANCE STRETCHER  
TROLLEYS - RISK OF FRONT LEG FRACTURE**

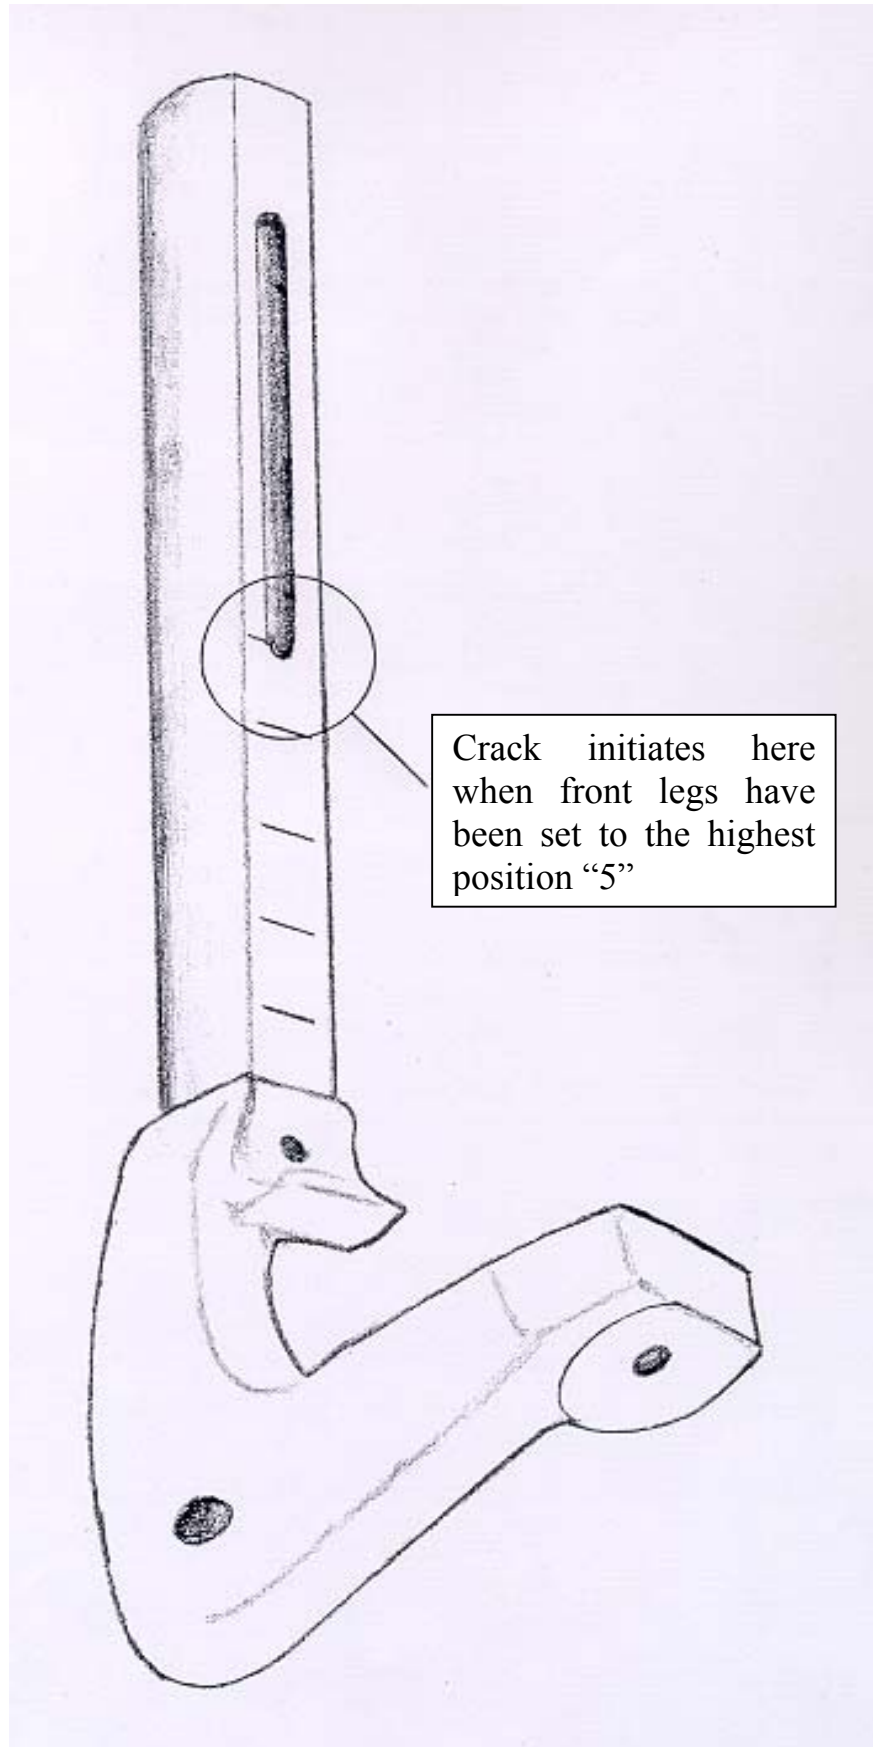
When Stollenwerk stretcher trolleys have been set up and used continuously in the highest position of front leg adjustment (position 5), it has been found in some cases to result in stress cracks initiating at the end of the milled slot in the inner front leg. This is shown in Annex 1.

**ANNEX 1 – FRONT INNER LEG SHOWING  
AREA WHERE CRACKING INITIATES**

- Users of Stollenwerk stretcher trolleys should check during every periodic vehicle service for indications of cracking around the area shown in Annex 1; particularly those trolleys where the telescopic front legs have been set in position 5.
- It is not possible to check inner telescopic leg sections for signs of cracking **without dismantling** the telescopic legs, as the affected areas are shrouded by the outer leg sections.
- All inner legs showing signs of cracking must be replaced, as per Paraid Ltd's maintenance procedures, before trolleys are returned to service.

These cracks may initially be very faint, hence the area must be examined thoroughly to enable them to be identified. Proprietary crack detection kits deploying dyes may help to identify these early indications of leg failure. It is advisable to perform any visual checking in natural light, not under workshop lighting conditions.

Records of these checks should be kept. The legs should be traceable e.g. with a label or bar code to identify how long they have been in service. When re-assembling the telescopic front legs it is imperative that fasteners are tightened to the correct torque as stated in Paraid's maintenance instruction. Paraid Ltd will replace all post-2000 front leg assemblies found to exhibit cracking, free of charge.
