Medical Device Alert

Ref: MDA/2009/059 Issued: 14 September 2009 at 14:00

Arjo Maxilift patient hoists
manufactured by Arjo Med AB Ltd.

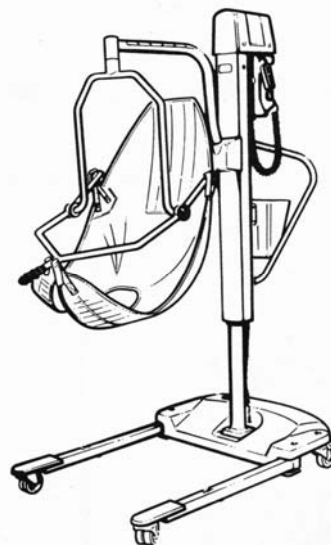
On certain designs of hoist, the hanger bar can detach from the jib during use due to corrosion and fatigue of the roll pin. This can cause the occupant to fall with subsequent serious injury or death.

- Trace all Arjo Maxilift hoists.
- Inspect the hanger bar attachment to identify the type of attachment and the action required.
- Ensure that all hoists are regularly maintained in accordance with the manufacturer's instructions.
