# Medical Device/Equipment ALERT

Ref. MDEA(NI)2003/32

Section								
<b>Medical Device/Equipment:</b> Blood Pressure and Vital Signs patient monitors - DINAMAP PRO 100-400 Series and PRO 1000	▶ ①								
<b>Problem:</b> Risk of electric shock. The mains input socket can be pulled out of the case exposing "live" parts.	▶ ②								
<b>Action by:</b> Estates Managers, Device Managers, Risk Managers, Health and Safety Officers and all Clinical, Medical, Nursing and technical staff who use or handle blood pressure monitors.	▶ ③								
<b>Action:</b> Dinamap monitors should be disconnected from the electrical mains outlet (wall socket) before being moved.	▶ ④								
<b>Distributed by NIAIC to:</b>

Blood Pressure and Vital Signs patient monitors - DINAMAP PRO 100-400 Series and PRO 1000. Manufactured by GE Medical Systems Information Technologies.

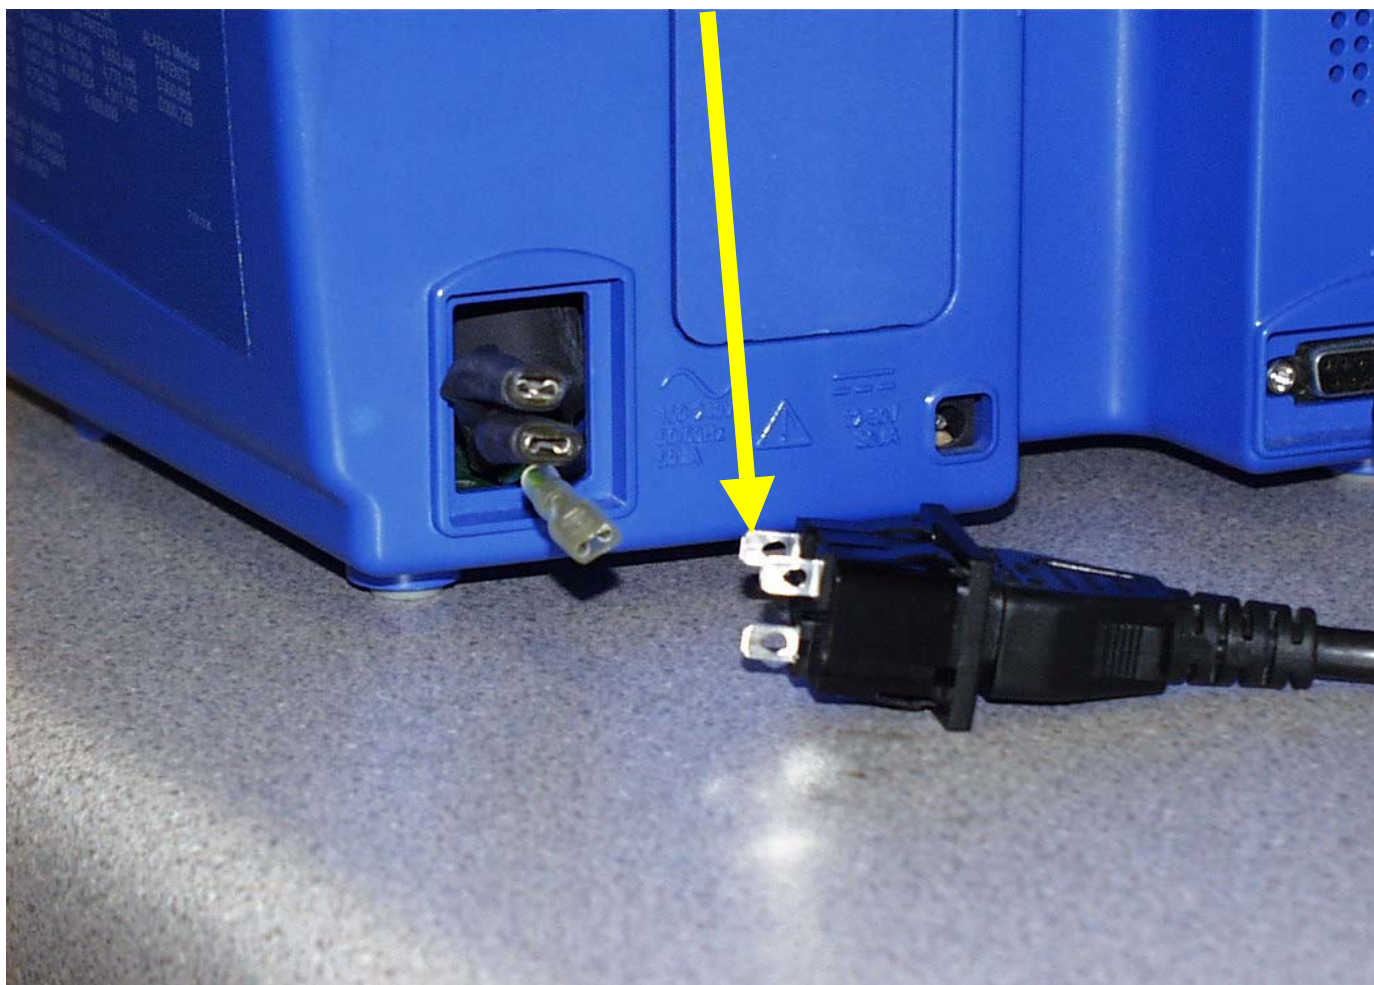
The Medicines and Healthcare products Regulatory Agency (MHRA) is continuing to receive reports where the mains input socket has detached from the back of the case exposing "live" parts. NIAIC has not received any reports concerning this issue in Northern Ireland. The continuing reports to MHRA are despite the issue of a MHRA Hazard Notice in August 2002 (NIAIC equivalent notice was HN(NI)2002/05) and completion of the manufacturer's modification programme where the power socket was glued to the rear panel.

- Users should be aware that the input socket may pull out from the back of the monitor's case while still attached to the mains cable. This exposes the user to "live" parts on the end of the mains cable presenting a risk of electric shock. (See Appendix for picture and our website [www.dhsspsni.gov.uk/niaic](http://www.dhsspsni.gov.uk/niaic) for colour photograph attached to electronic copy of this notice).

### BEWARE LIVE TERMINALS - DO NOT TOUCH

The Company is aware of this problem and has initiated corrective action. All units in the field that are fitted with the Schurter appliance inlets, whether previously glued or not, will be modified with a metal reinforcing plate. The UK Service Group expects to begin this action by 15th November, with completion in the early portion of 2004. A Customer Letter will be sent out shortly.

- Users should ensure that the mains plug is disconnected from the electrical mains outlet (wall socket) before moving the DINAMAP monitor.
- Do not disconnect the cable from the rear of the monitor before disconnecting from the mains outlet.

- In the event of the mains cable pulling out of the monitor during use, do not touch the mains cable. Ensure the mains plug is disconnected from the mains outlet before examining the cause of the problem. If the input socket has detached completely or partially from the rear of the case, do not attempt to re-connect the mains cable. The unit should be removed from use and quarantined, pending modification.
