**NORTHERN
IRELAND
ADVERSE
INCIDENT
CENTRE**

TITLE:
**ARJO TRIxie PATIENT HOISTS:
RISK OF INSTABILITY AND USER INJURY**

Enquires to the NIAIC should quote the reference number SN(NI) 2002/38 and be addressed to:

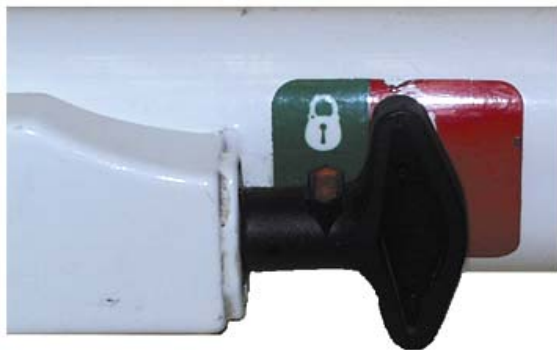
Figure 1

Modifications required to ensure the safety of Arjo Trixie hoists may not have been undertaken. If the ‘Tee’ shaped leg lock handles are not correctly locked or make contact with other equipment when being used, it may be possible for the lock handles to be released, presenting an instability risk to all those using the hoist.

NIAIC has been informed that the Medical Devices Agency (MDA) has received reports of nine incidents where injuries have occurred, and more serious injuries could have occurred. When the hoist is used near other equipment such as a wheelchair or a bed, parts of the other equipment could catch the 'Tee' shaped leg lock handle and cause it to release, allowing the hoist to tilt to one side.

**'TEE' Shaped Leg Lock
Handle: Needs Replacing**

Identify all Arjo Trixie hoists in use. Check that the ‘Pear’ shaped leg lock handles shown in fig 2, Annex 1 are fitted and NOT the earlier designed ‘Tee’ shaped leg lock handles shown in fig1, Annex 1.

- If the ‘Pear’ shaped leg lock handles are fitted, no further action is necessary and use can be resumed.
- If the ‘Tee’ shaped leg lock handles are fitted, users should contact Arjo Ltd to make arrangements for replacement handles to be supplied and/or fitted at the earliest opportunity.

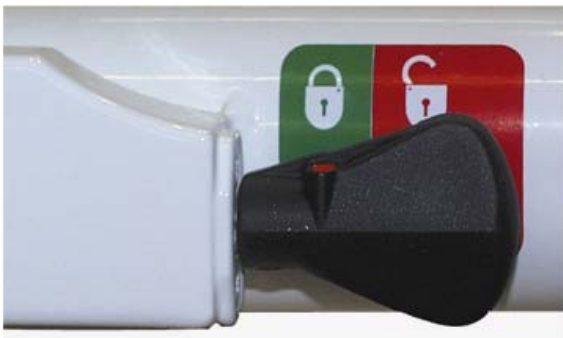
Figure 2

**'PEAR' Shaped Leg Lock
Handle: Not Affected**
